# **Stamp Legibility**

# 4 Parts of the ISPM 15 Mark

FIMBER PRODUCTS We Deliver Confidence.

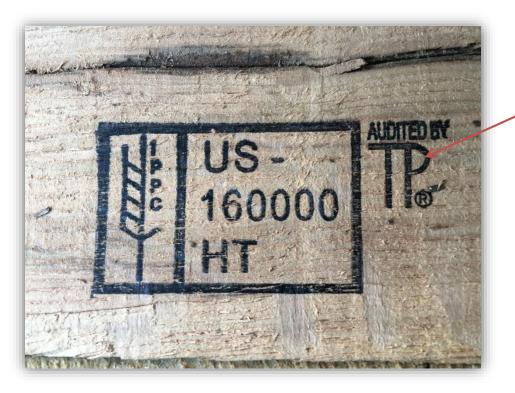
This mark is considered legible.

<u>ALL</u> parts are legible and complete.

- 1. "IPPC" LOGO
- 2. US 16000 HT
- 3. "TP" LOGO
- 4. BORDERS

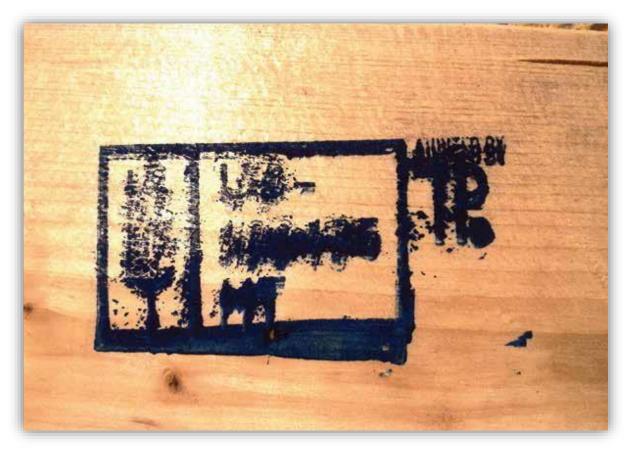
There are **NO** parts of this stamp that are readable.

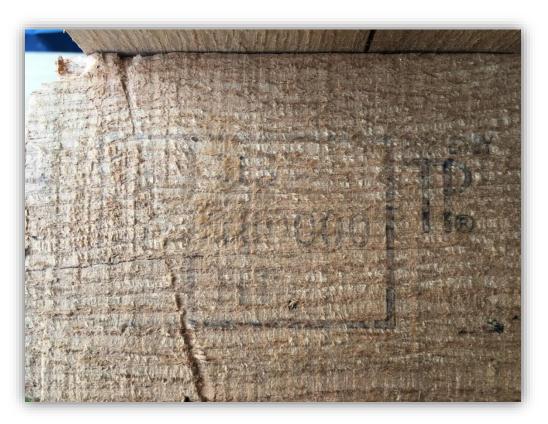
This mark was applied with to little ink and not fully readable.

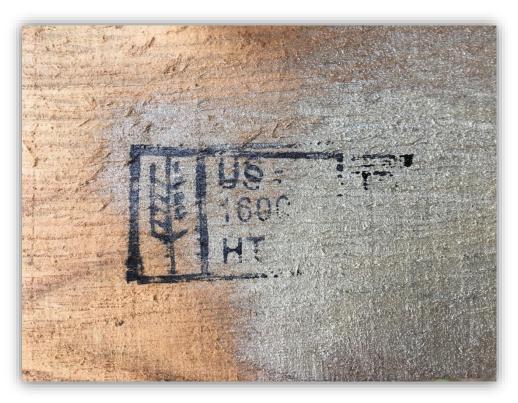
This stamp was not fully pressed to the wood causing part of the mark to be missing and incomplete.

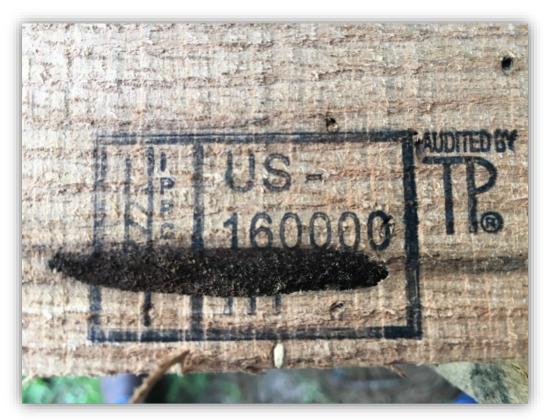
This mark was applied where a grub hole is present making the mark incomplete.

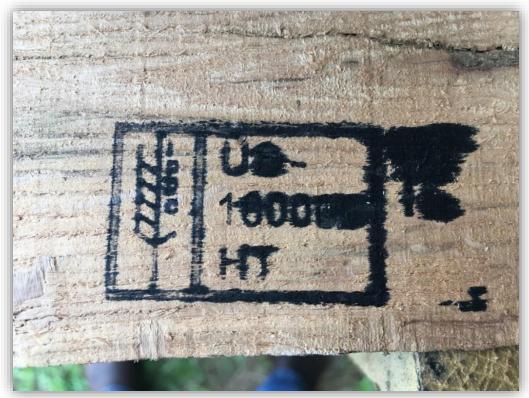
To much ink on the stamp has caused part of this mark to be unreadable.

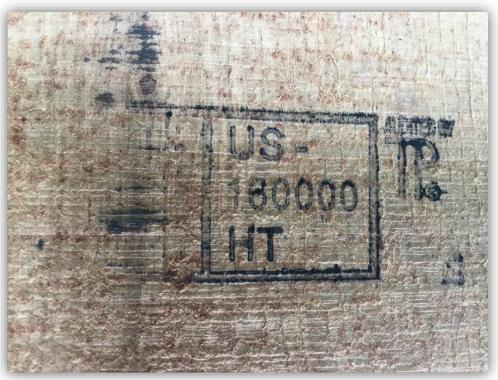
An uneven area where the wood was stamped caused part of the wheat symbol and border to be missing and is incomplete.

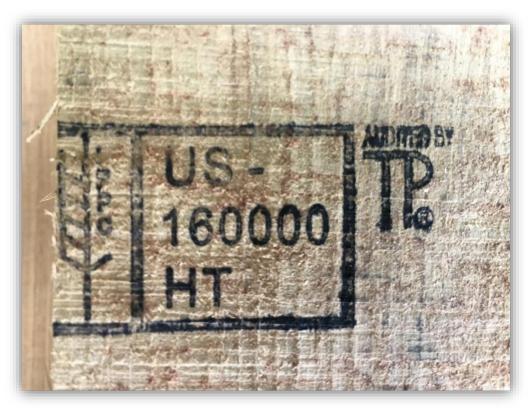
This mark was applied close at the edge of the wood and the left border is missing making it incomplete.

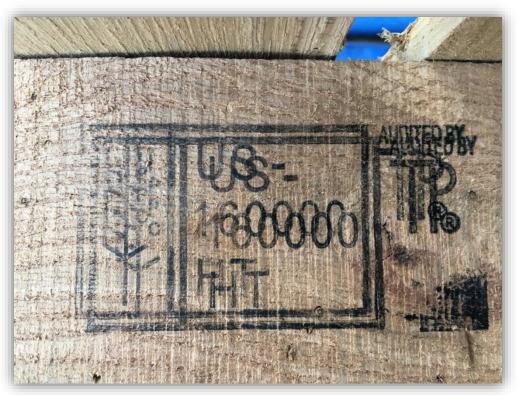
Re-stamping over an illegible mark causes both marks to be unreadable and therefore illegible.

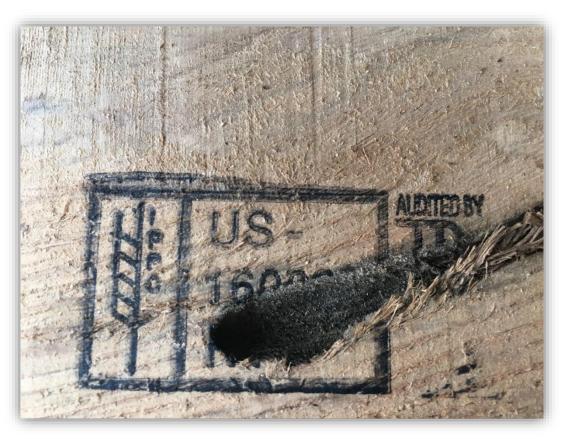
This mark was applied where a grub hole is present making the mark incomplete.

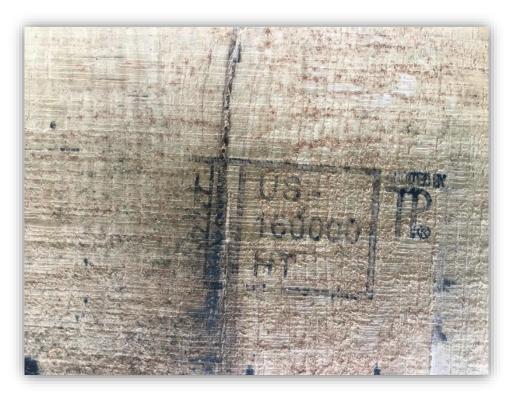
This mark was applied in an area where the wood is uneven and pith is present making the mark incomplete.
