Heat Treat Chambers

Proper Protocols for Use.

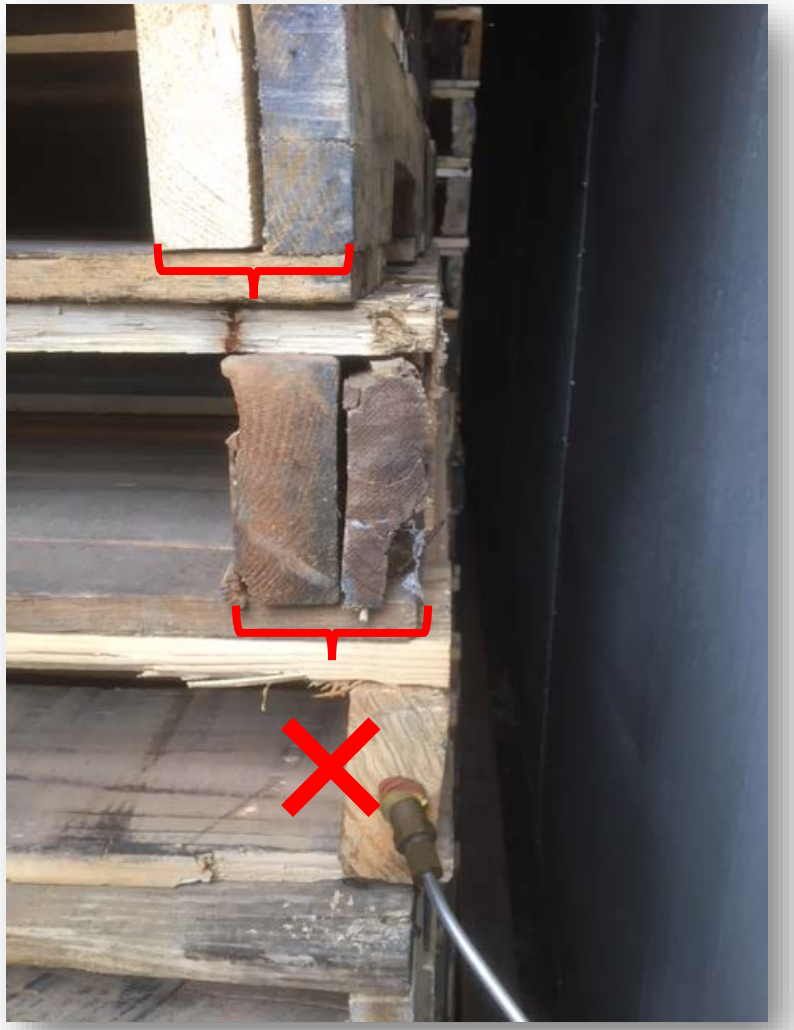
When companion stringers are used in the repair of WPM, the combined thickness of the two pieces must be used to determine the thickest wood in the chamber. This thermocouple was placed in a single stringer which would not be considered the thickest piece of wood.

You cannot sandwich the thermocouple in-between the two pieces either as heat can conduct to it. In this situation, a surrogate block should have been used that is equal to the thickest combined pieces in the chamber. If the doubled 2x4's are the thickest pieces in the chamber a solid 4x4 surrogate block should have been employed as the surrogate thermocouple location to properly measure wood core temperature.

This is a non-conformance.

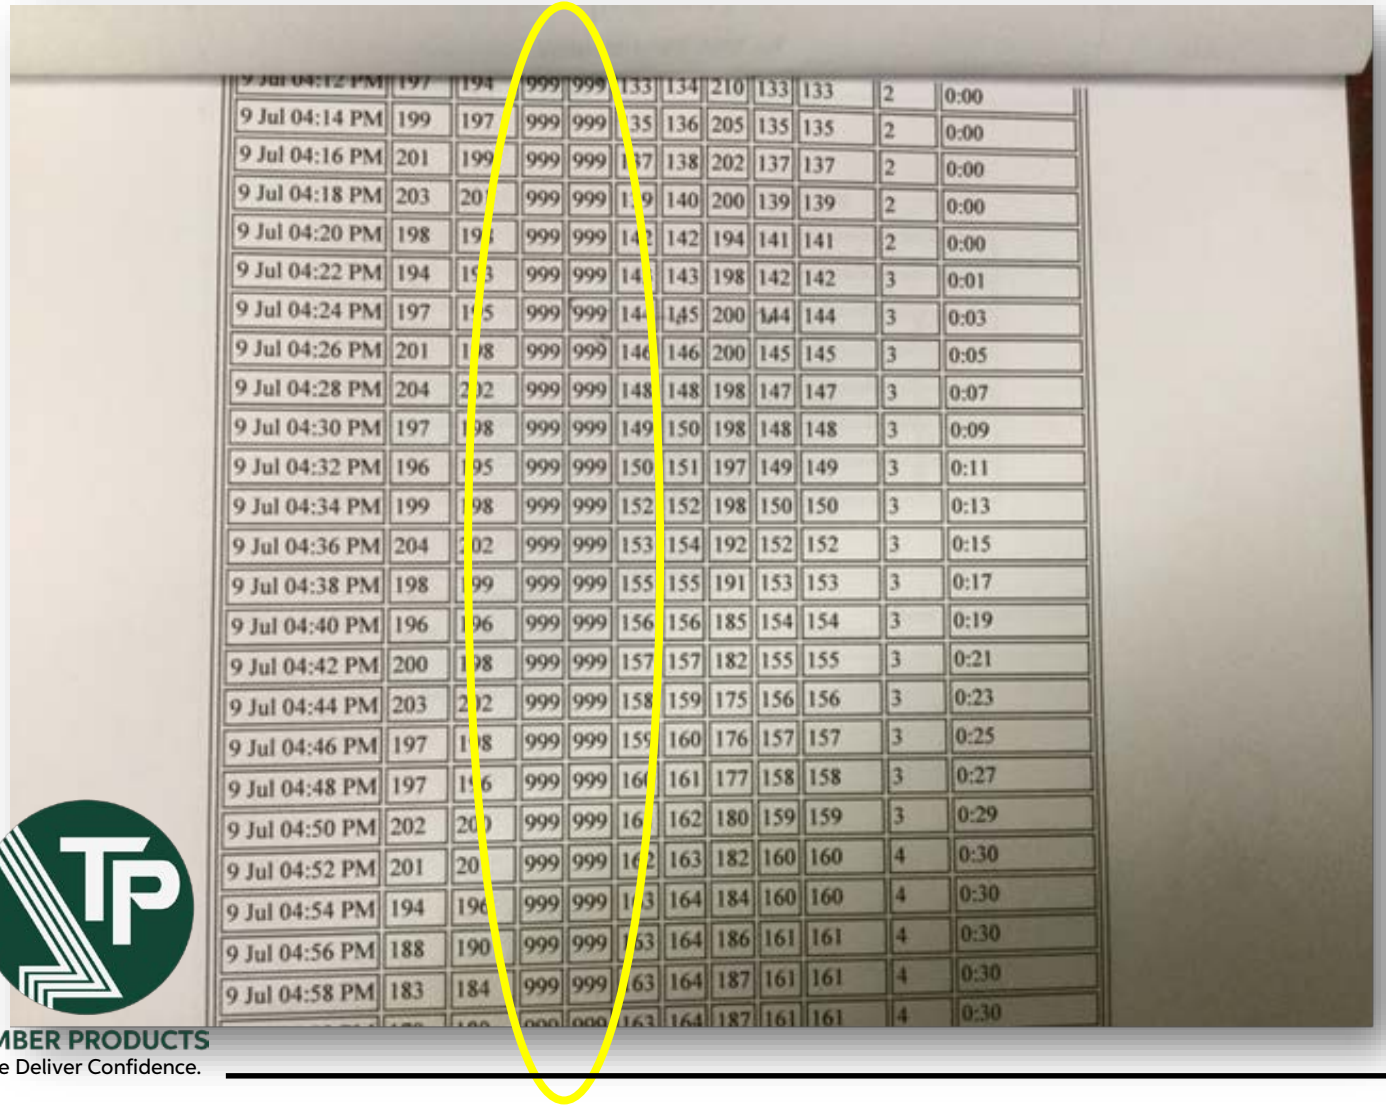
The report shown has an error code showing on both sensors of the first thermocouple and as a result is not providing any temperature information.

This is a non-conformance.

At least one sensor must be working on each probe to measure conformance.

The thermocouple with error codes should be replaced and the WPM retreated where all thermocouples show conforming time and temperature requirements.

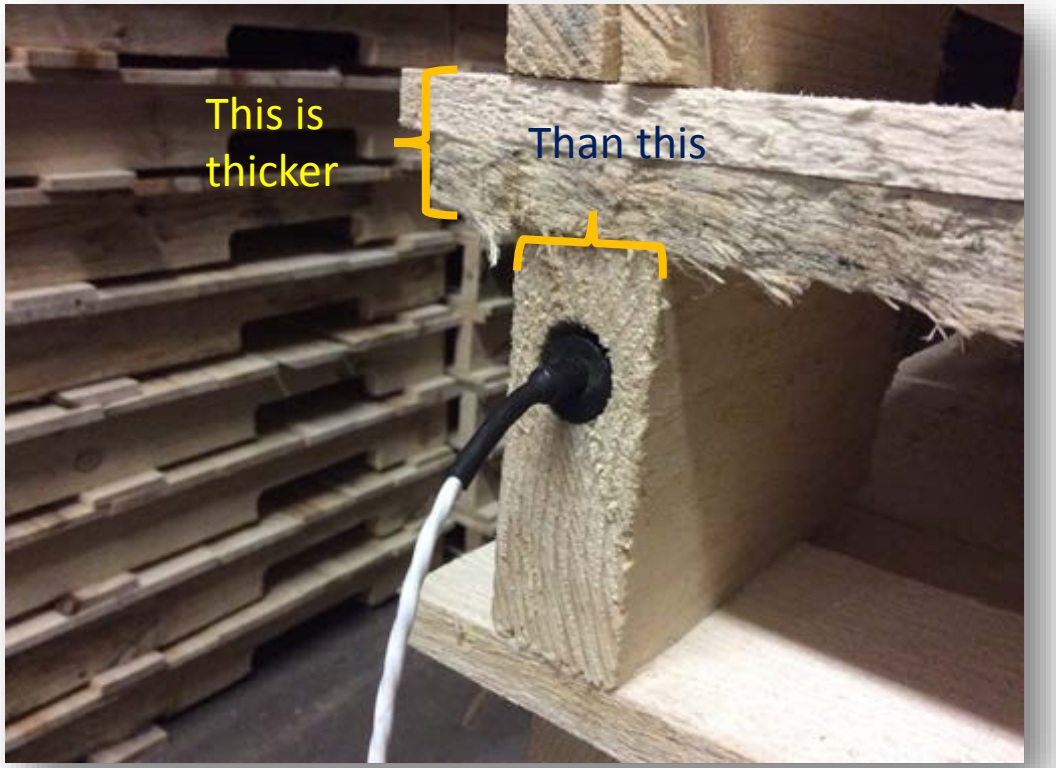
In this example, the adjoining deck boards are thicker than the stringer the thermocouple is placed in. A surrogate block that is as thick or thicker than the combined thickness of the adjoining deck boards should be employed to position the thermocouple.

This is a non-conformance.

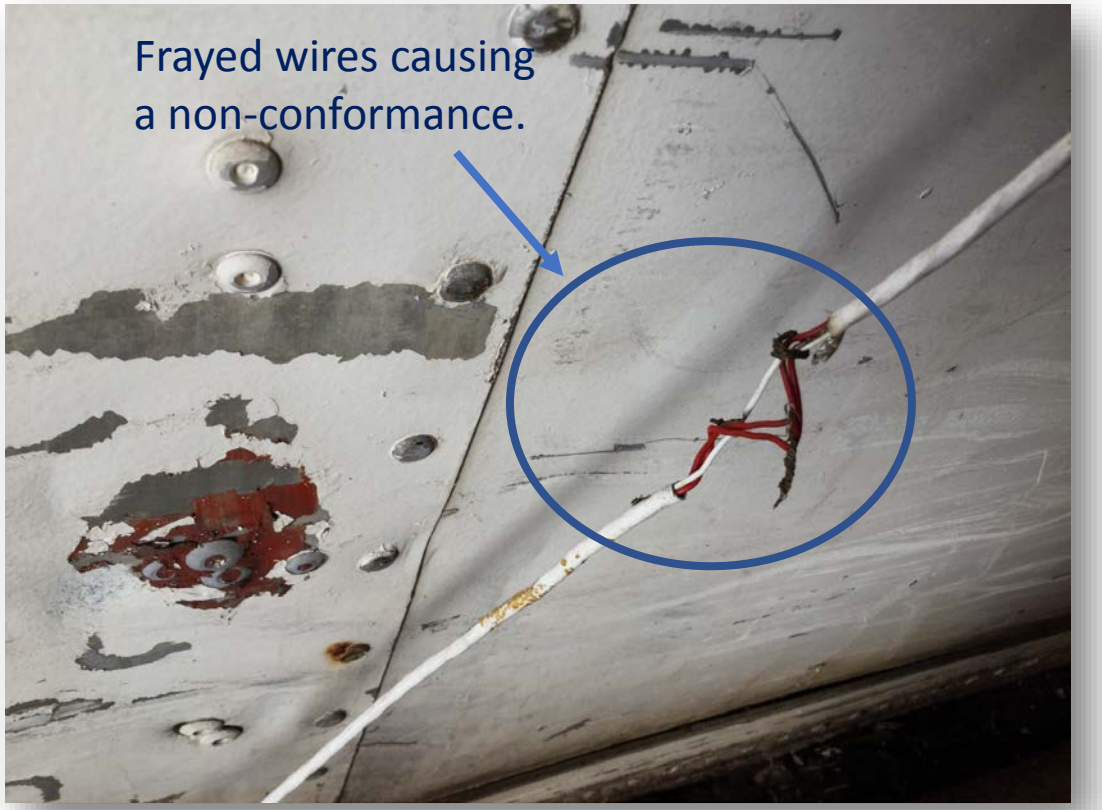
All equipment in the heat chamber must be in good working order. Frayed thermocouple wires, major leaks in the chamber, and other equipment not in good working order can cause a non-conformance.

This is a non-conformance.
